# Accessible Playground Surfaces

**A Longitudinal Study of Playground Surfaces to Evaluate Accessibility**

Conducted by  
National Center on Accessibility

## Purpose of Study

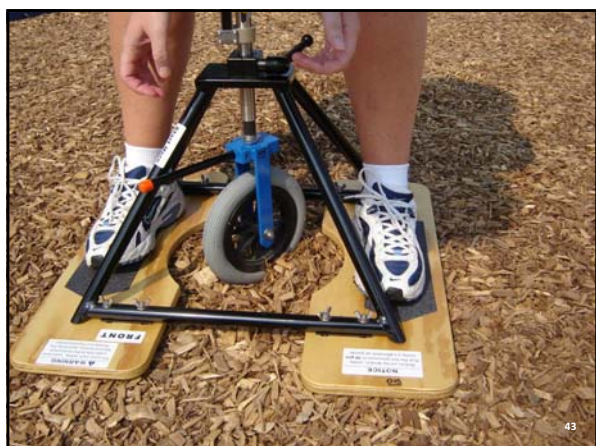
- Rotational Penetrometer
- Developed by Beneficial Designs as a portable field test to replace ASTM 1951.
- Wheelchair caster set in spring loaded caliper.
- Measures the vertical displacement of the penetrator.

A photograph showing a person in a blue shirt and white cap using a rotational penetrometer on a surface. The person is leaning over the device, which is mounted on a tripod. The device has a wheel and a spring-loaded caliper.

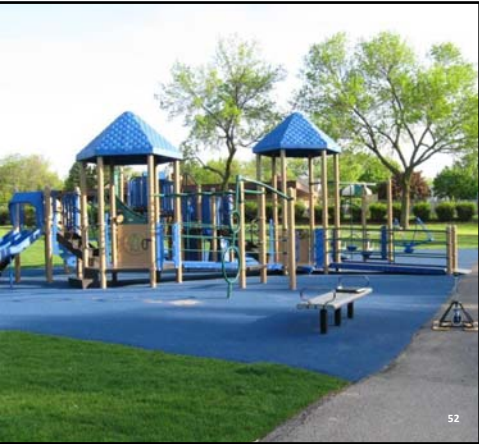
PIP  
\$6.59 -  
19.80

SDS  
Mean = .04  
Mode = 0

Firmness  
.34531

Stability  
.38357

Sum  
.72888

Failure for  
impact  
attenuation

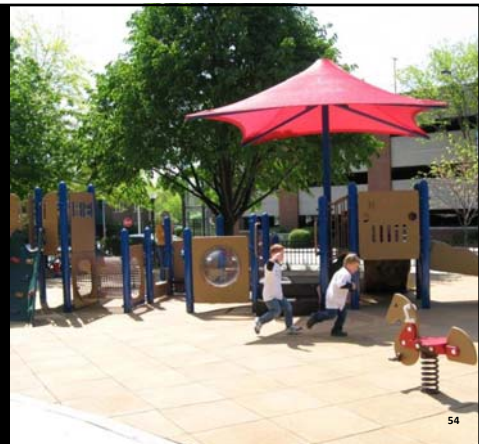
Tiles  
\$8.96-21

SDS  
Mean = .50  
Mode = 0

Firmness  
.27504

Stability  
.30989

Sum  
.58493

Changes  
in level

Separation  
at seams

Punctures
